**Flood Control Project Maintenance
Levee Inspections**

Maintenance Issue Types Only, Levee Inspection Report By Mile - Spring 2018

Reclamation District No. 1601 Twitchell

Waterway	Bank	Unit Miles	Inspection Start/End	Inspector
Unit No. 01 Threemile Slough	Left	2.43	03/22/2018 03/22/2018	Keith Millard

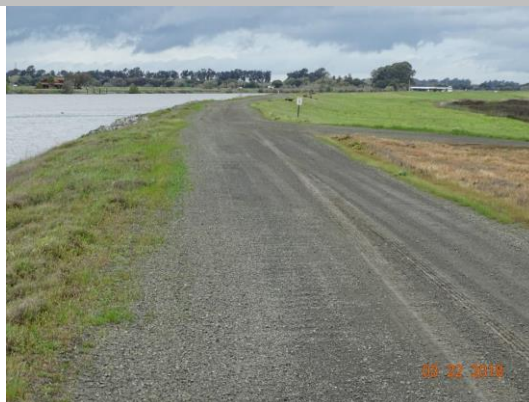
Photo 1 of 1 : SP_2018_RD1601_237_4_20180322_00020.jpg

LM Start	1.97	Rating **	A	Issue No.	4
LM End	1.97	Issue Type +	Ma	Location *	LS
Category	Earthen Levee		GPS Latitude/Longitude		
			Start	End	
Item	Vegetation		38.094153 °	38.094153 °	
			-121.684697 °	-121.684697 °	
DWR ID	DWR_RD1601_01_s_2018_4				
Comment Code					
V1 : Control annual grass and weeds on the levee slopes and easements.					
Inspector Comment					
Landside vegetation is well managed.

Well managed landside vegetation.
